NASA TM X-1794

**EXPERIENCES WITH BERYLLIUM
SWELLING AND REPLACEMENT
IN THE PLUM BROOK REACTOR**

by William Fecych

*Lewis Research Center
Cleveland, Ohio*

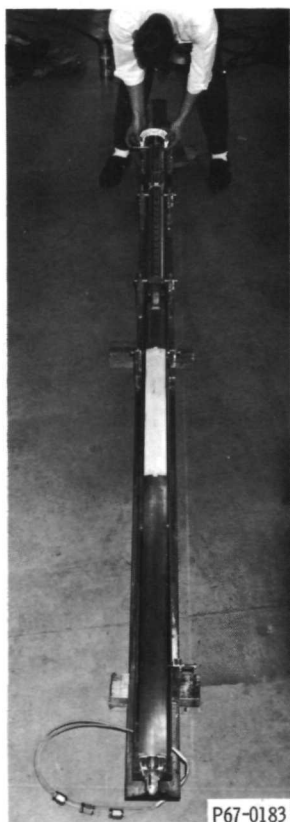
Figure 3. - Alinement jig with assembled control rod.

During control rod drop tests in February 1967, the control rod, located in core position LA-8, would stop under no-flow conditions about 1 foot from its seated dashpot position. The rod would fall properly when the locking bolt located on the top of the poison section was loosened. This allowed the control rod sections to hinge.

A special alinement jig was made to measure the assembled control rods (fig. 3). Figure 4 shows the alinement jig in the Hot Laboratory with a bowed beryllium section installed. The bowed assembled rod is shown to be $3/8$ inch away from the zero reference screw. Each beryllium reflector control rod section has an aluminum box at each end

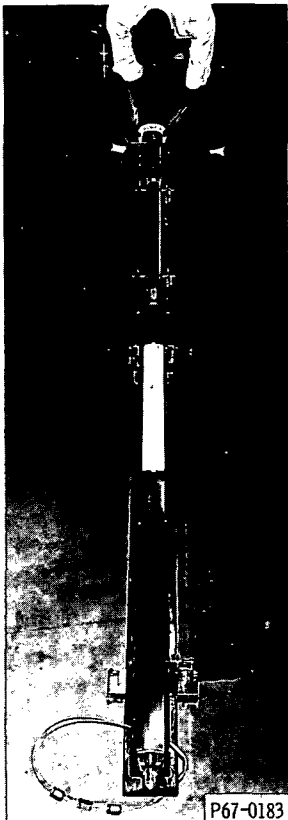
Figure 3. - Alinement jig with assembled control rod.

During control rod drop tests in February 1967, the control rod, located in core position LA-8, would stop under no-flow conditions about 1 foot from its seated dashpot position. The rod would fall properly when the locking bolt located on the top of the poison section was loosened. This allowed the control rod sections to hinge.

A special alinement jig was made to measure the assembled control rods (fig. 3). Figure 4 shows the alinement jig in the Hot Laboratory with a bowed beryllium section installed. The bowed assembled rod is shown to be $3/8$ inch away from the zero reference screw. Each beryllium reflector control rod section has an aluminum box at each end
